## Mrs E - Shropshire

### Property Type – Mill House and Cottage

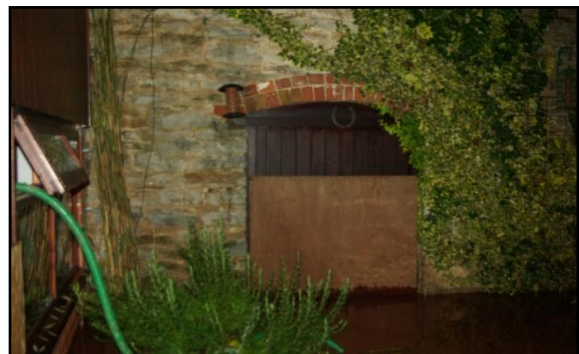
### Door Barrier in action

In September 2008 when the river rose, we installed the door barriers which worked well,

but the water found its way through weak points in floors in the ground floor rooms in the mill as there was differential pressure between inside and out. In the cottage the door barriers and waterproof membrane to floors were effective in keeping out the river water, but clean

- We had purpose-made 18 mm marine ply door barriers made for all doors and one vulnerable window in the cottage, which screwed into the timber frames. Expanding rubber strips fixed to each barrier sealed it when compressed.
- We installed an automatic sump pump in the workshop in the mill as there was only a partial floor in there through which water might penetrate. We also tanked the wheel well in the workshop to stop water rising up it from outside. The

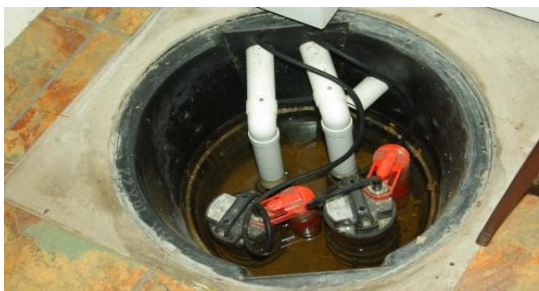
### Automatic sump pumps

warm water (possibly from a spring) appeared under the stairs which we managed to control by scooping it out manually, minimising damage in the cottage to the carpets.

- In the cottage 2 powerful automatic sump pumps were installed buried in the ground under the stairs with an aqua channel. In the case of a flood this will pump out any water before it reaches ground floor level. This together with the barriers will solve the problem in the cottage.
