## Dr R - Oxfordshire

### Detached property

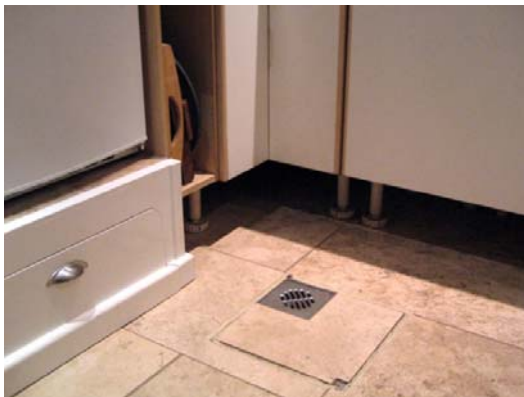
They have fridge (fig. 1), freezer and washing machine up on platforms with storage space

below. They are actually easier to use at this height! Electrical points are well up off the floor. Kitchen units are anyway on plastic legs. The plinths unclip (common) and can be removed if a flood looks likely. Fig. 1 shows the units with the plinths removed. There was no need for special waterproof units as the water doesn't get deep enough if the pump is doing it's pump is doing its job.

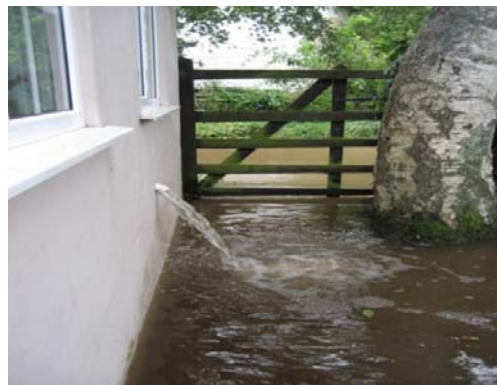
Fig 2

At the same time they had a sump (just a pit below floor level, in this case with a plastic drum lining it) dug in one corner of the kitchen, and in which sits a submersible electric pump. Water coming into the house runs across the floor and down through the grating (fig. 1) into the sump below. It's then pumped back out into the garden (fig. 2).

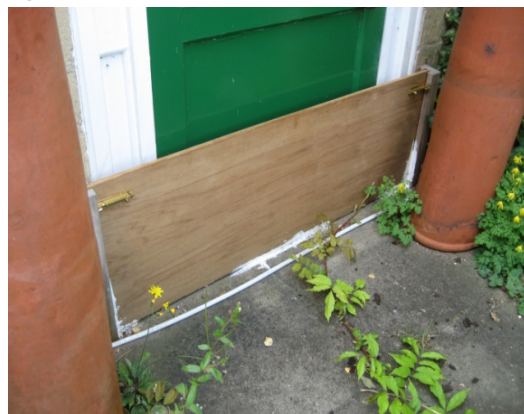
Fig 3

Dr R could not get ready-made flood boards to fit their door frames so they got a Carpenter to fix grooved hardwood supports either side of the door and at flood time They slide in a marine ply board, with a rubber seal on the lower edge and two brass bolts into the supports to hold it in place - though mastic is still necessary
